**Improving Asphalt Concrete
Mixtures' Resistance to Studded
Tires and Chains Wear**

A thesis submitted in partial fulfillment of the
requirements for the degree of Master of
Science in Civil and Environmental
Engineering

Vanessa Khoury

May, 2024

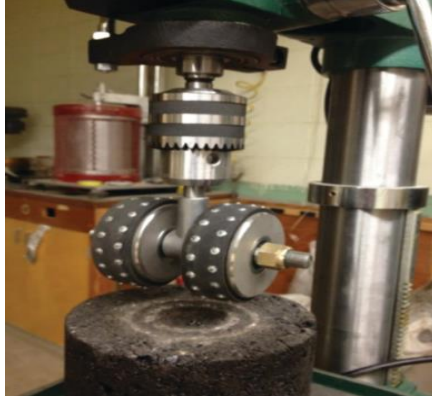
Figure 6. Studded tires simulator (Wen & Buhsal,2014)

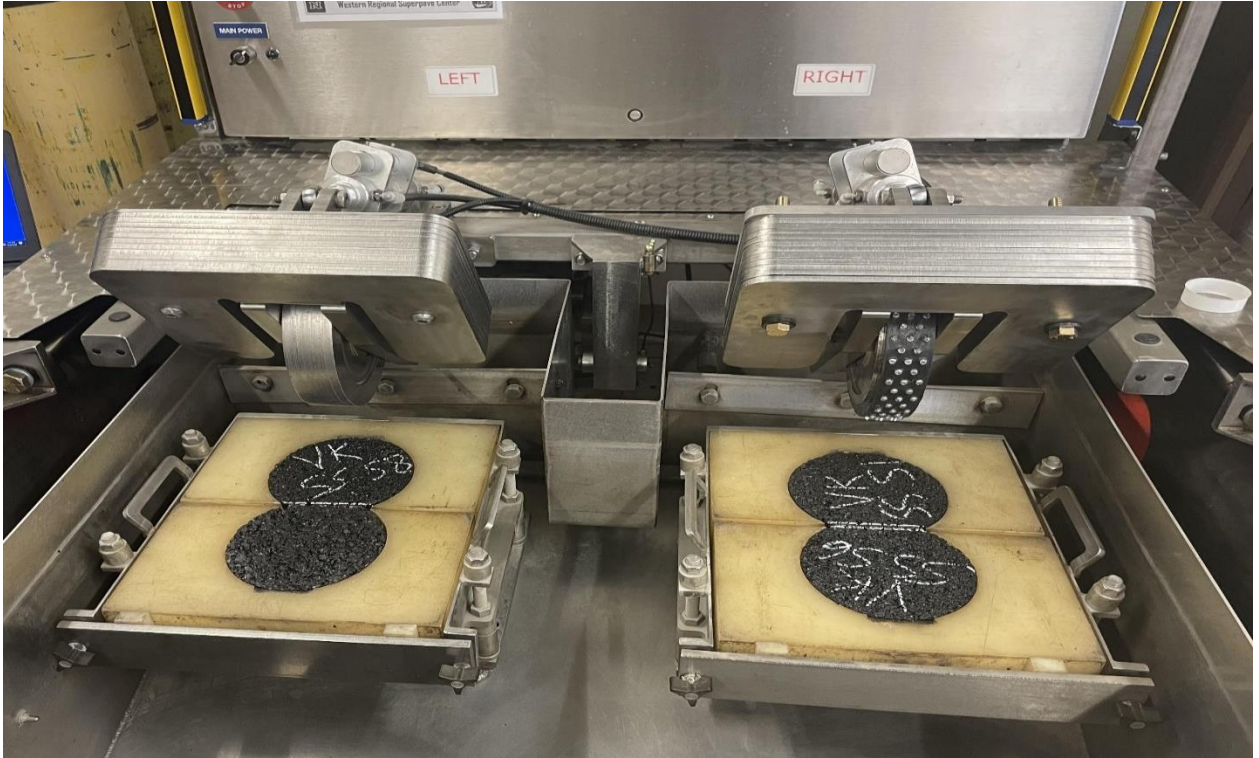
Figure 8. Hamburg Wheel Track Test Setup

Condition	Structure	Wheels Load	Sample Height	Dry/Wet	Temperature (°C)
1	Open Graded	705±4.5 N	60±2 mm	Dry	23
2	Open Graded			Wet	50
3	Open Graded + Dense Graded			Dry	23

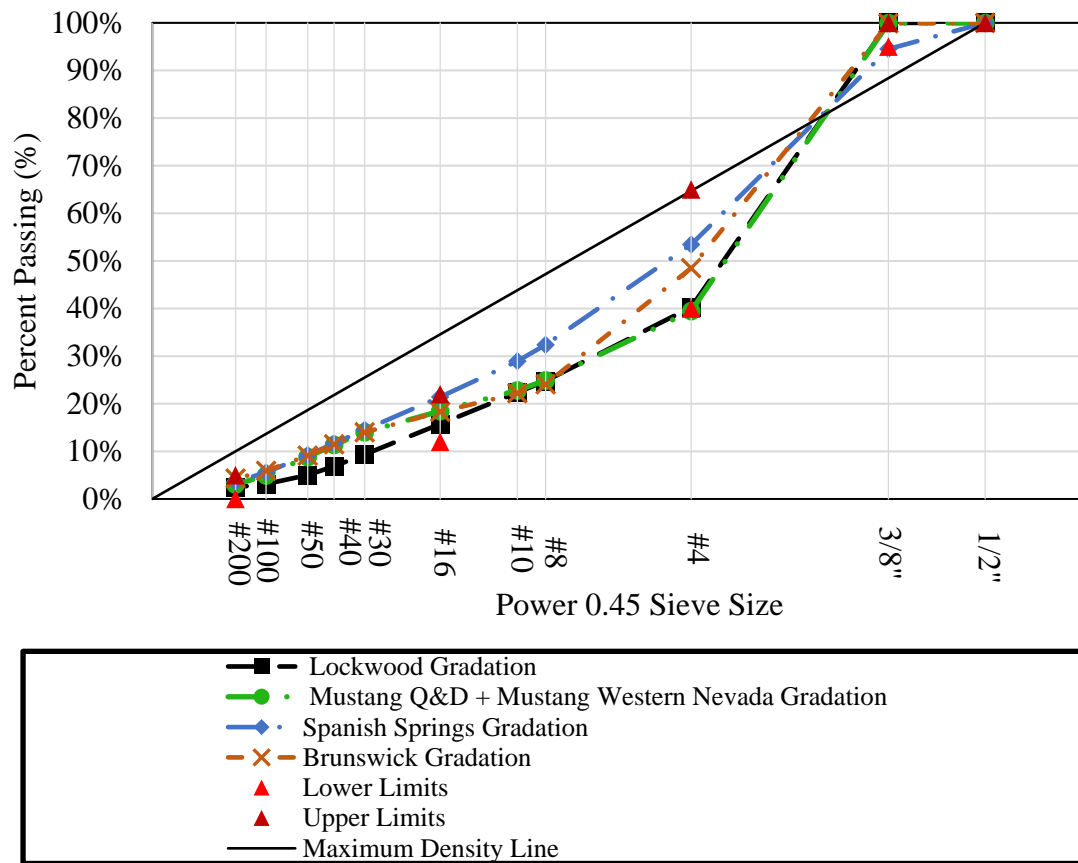
Figure 9. Aggregate Gradations for all Sources

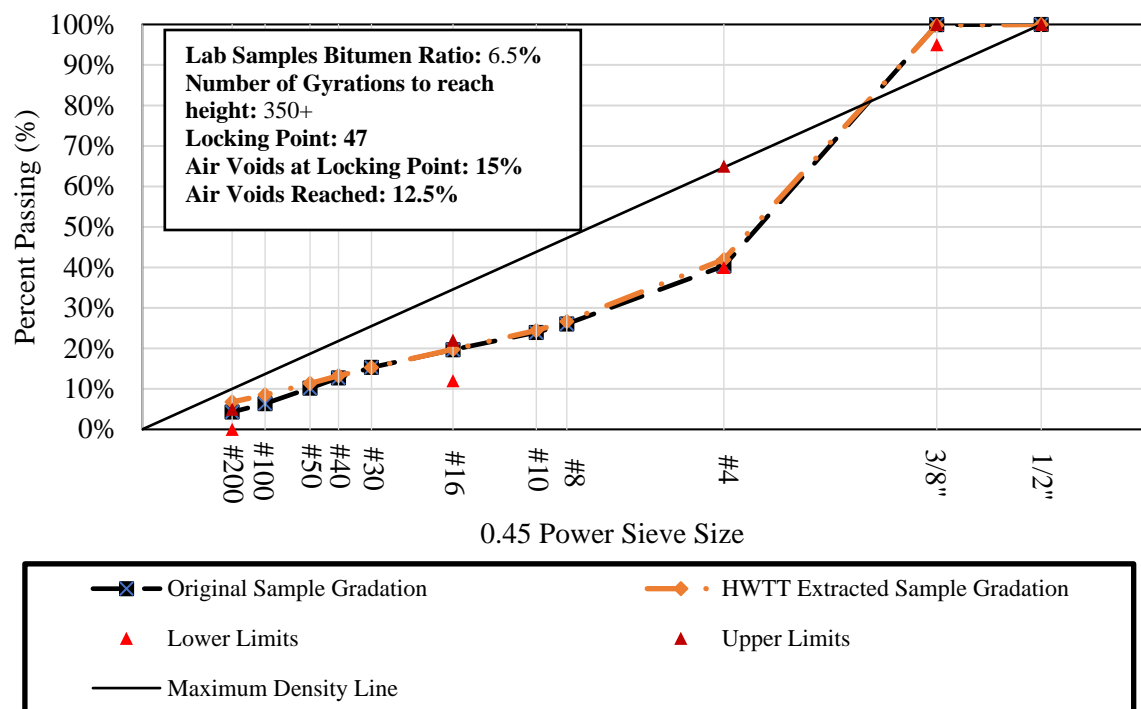
Figure 11. Lockwood HWTT Aggregate Gradation Before and After Compaction

After noticing a difference in the gradation as shown in Figure 10 and Figure 11, it was agreed to compact the samples to the SGC locking point (Polaczyk et al., 2019).

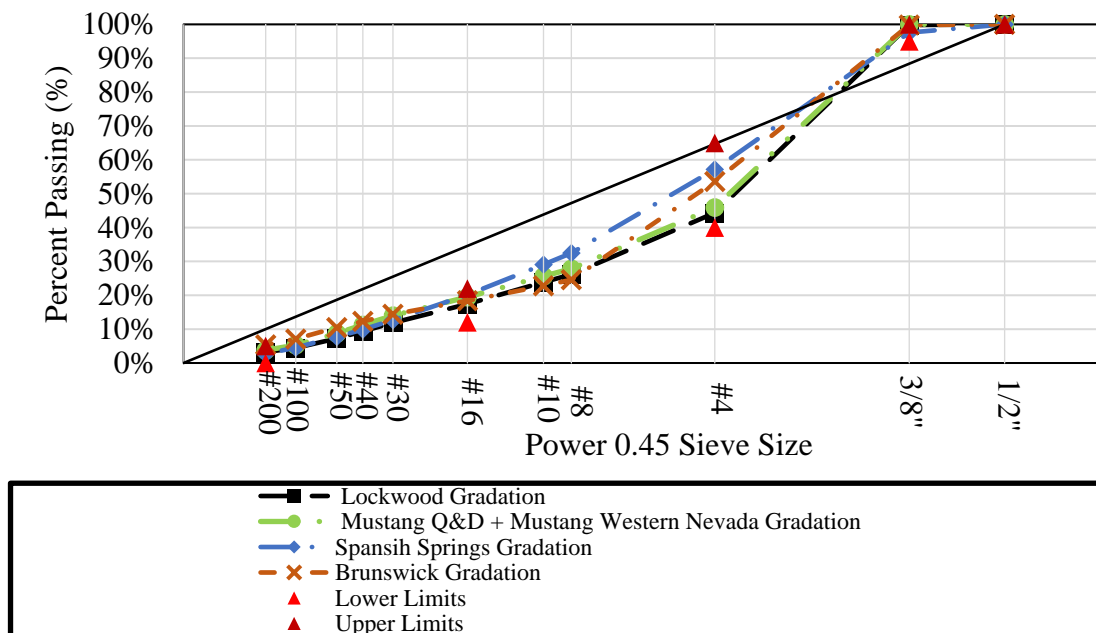
Figure 13. Sieve Analysis Test Results for all Sources.

Both a wet and dry sieve analysis were performed for each source to confirm the gradation provided by the most recent NDOT mix design. The results of the sieve analysis for each source are shown in Figure 13. The gradation used for each test was the one in the NDOT mix design and they are shown in Figure 14 for each aggregate source. The sieve analysis confirmed the gradations of the mix designs with slight differences on the #4 sieve. The Lockwood and Mustang sources had the coarsest gradations compared to the Brunswick and Spanish Springs sources.

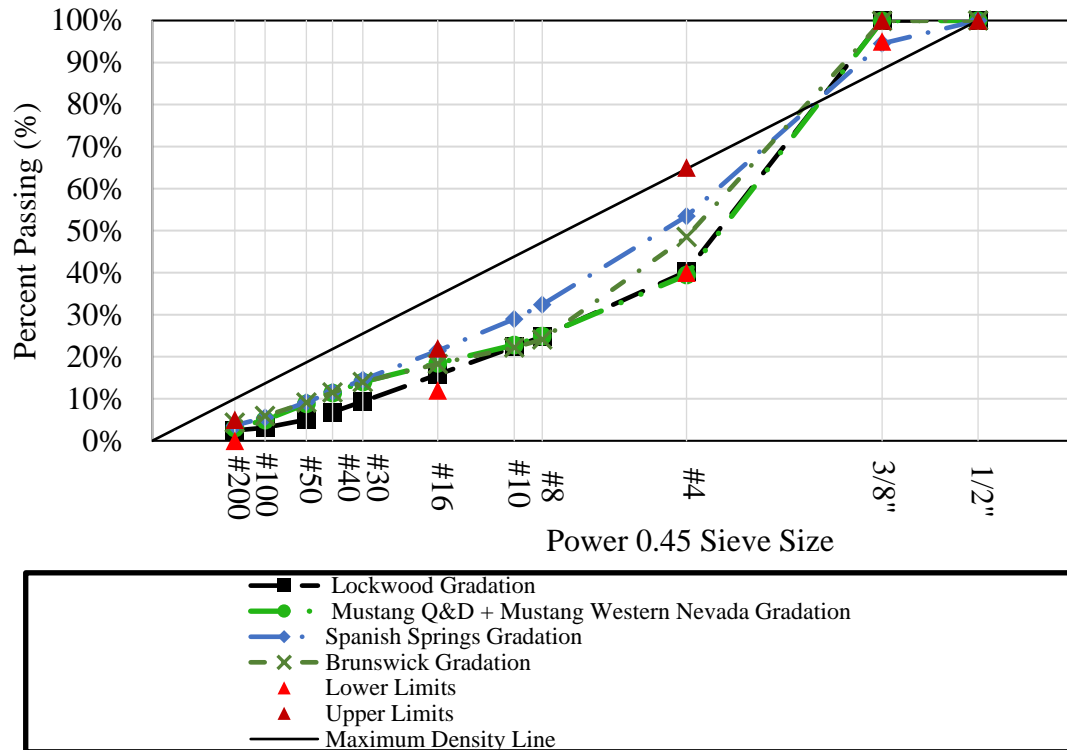
Figure 14. NDOT Mix Designs Gradations for all Sources.

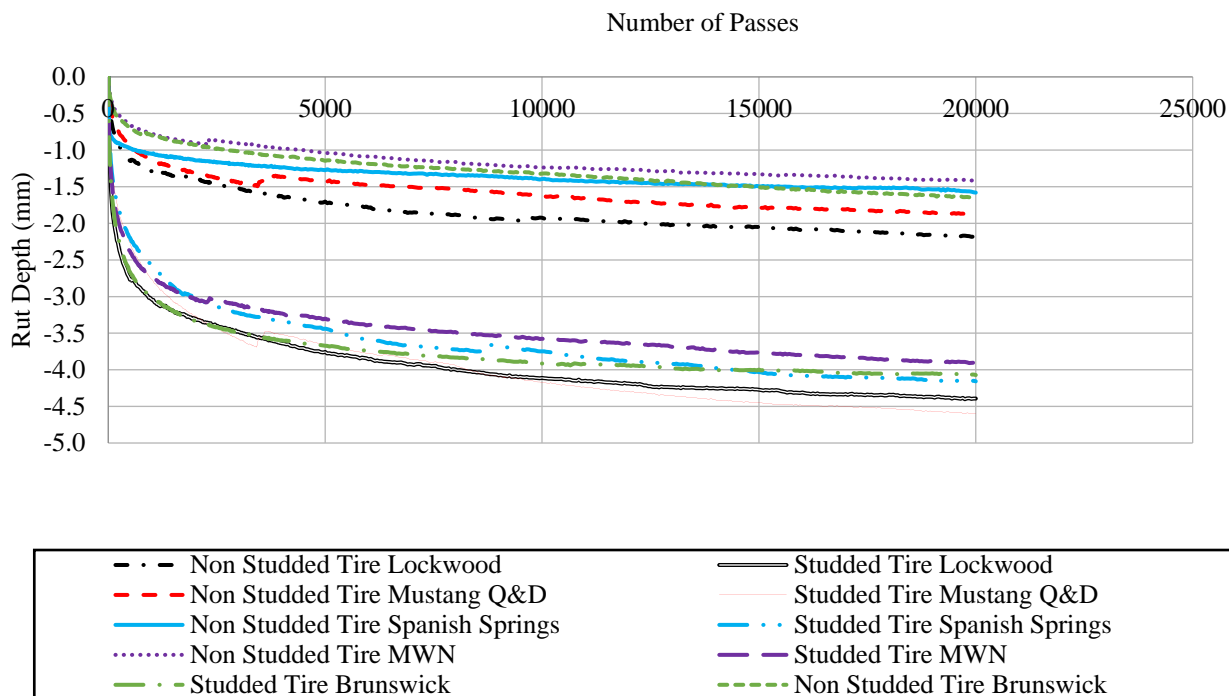
Figure 37. Hamburg Wheel Track Test Results (Condition 1)

The HWTT results for Condition 1 are shown in Table 7. The studded tire resulted in greater rut depths compared to the non-studded tire for all the aggregate sources. Based on the results, it could be concluded that all sources performed similarly although they have different binder contents, gradations, air voids and mineralogies. Pictures 17 through 36 show the condition of samples after testing for both studded and non-studded tires. Table 16 shows a summary of the test conditions and the results. Figure 37 illustrates the Rut Depth versus the number of passes curve for each aggregate source. The samples were barely damaged, and this was expected as the test was performed at intermediate temperature in a dry (no water) condition.

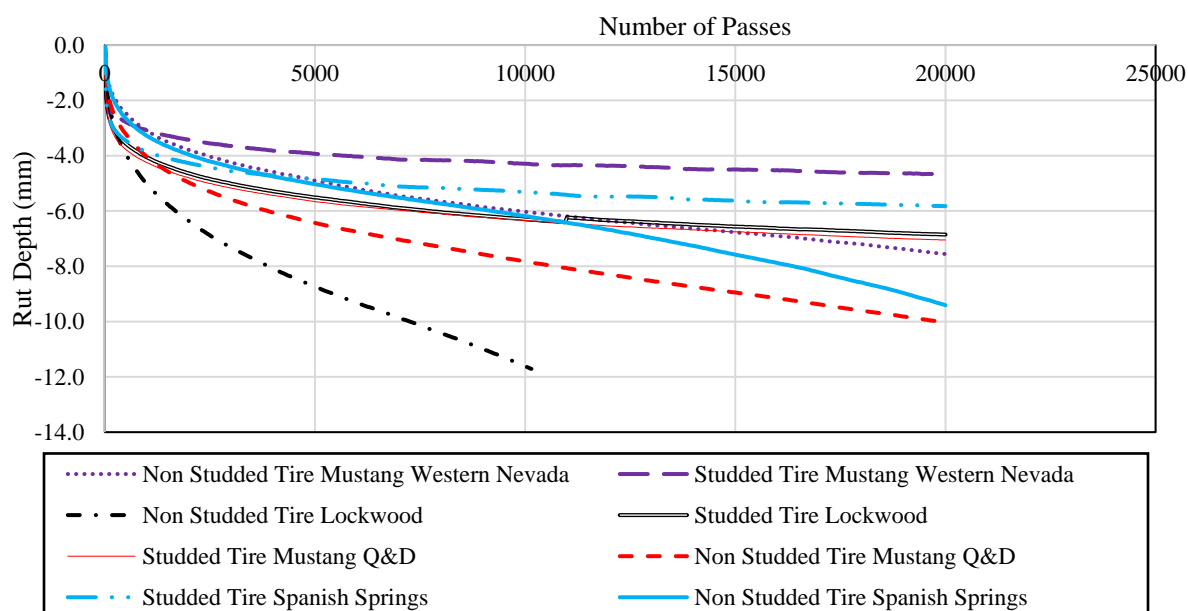
**Figure 54. Hamburg Wheel Track Test Results (Condition 2)**

Condition 1 did not generate significant damage to the asphalt concrete mixtures tested and the comparison between the performance of the different sources was not possible, therefore condition 2 was introduced. In this test, the non-studded tire resulted in higher rut depths compared to the non-studded tire. In addition, the effect of water was evident as stripping was observed for the Spanish Springs materials only. Also, Lockwood samples reached the rut depth threshold set for this test (12.5 mm) after approximately 10000 cycles. Figures 39 through 53 show the condition of samples after test with both studded and non-studded wheels. Due to time restrictions, the Brunswick Material was not tested under Condition 2. Table 17 shows the summary of HWTT results at condition 2. Figure 54 illustrates the rut depth versus the number of passes curves.

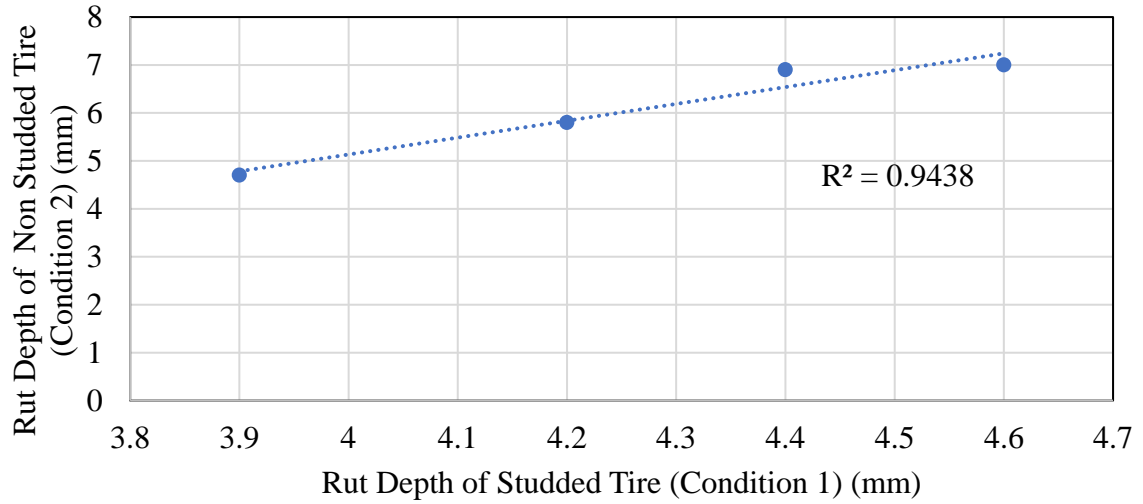
Figure 79. Rut Depth of Non Studed Tire at Condition 2 versus Rut Depth of Studed Tire at Condition 1

Correlation was found between the fine aggregate durability index test and the Prall Abrasion value. Furthermore, significant correlation was found between rut depth resulting from the studded tire at Condition 1 and the rut depth resulting from non-studded tire at Condition 2. Additionally, a relationship was observed between rut depth resulting from studded tire at Condition 2 and the rut depth resulting from non-studded tire at Condition 1.

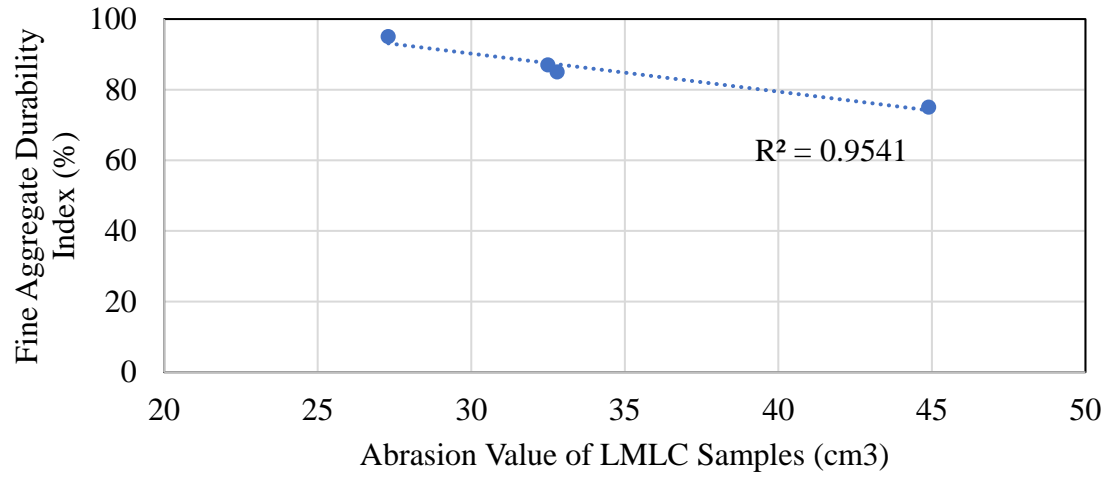
Figure 81. Fine Aggregate Durability Versus Abrasion Value of LMLC
